Papers published in *Hydrology and Earth System Sciences Discussions* are under open-access review for the journal *Hydrology and Earth System Sciences*

Experimental study using coir geotextiles in watershed management

S. Vishnudas¹, H. H. G. Savenije^{1,2}, P. van der Zaag², K. R. Anil³, and K. Balan⁴

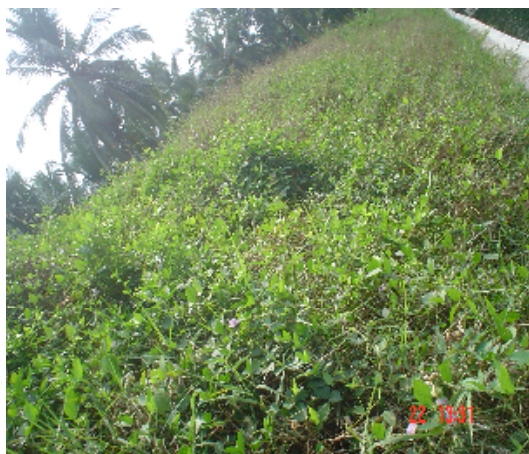
Fig. 7. CG, natural vegetation after 7 months.

The community monitored and evaluated the growth of vegetation in the treatment plots. Response of the community with respect to the three treatments in terms of uniformity and density are shown in Figs. 4 and 5, respectively. Figures 6a, 6b, 7 and 8 show the difference in growth of vegetation in CGG, CG and CP.

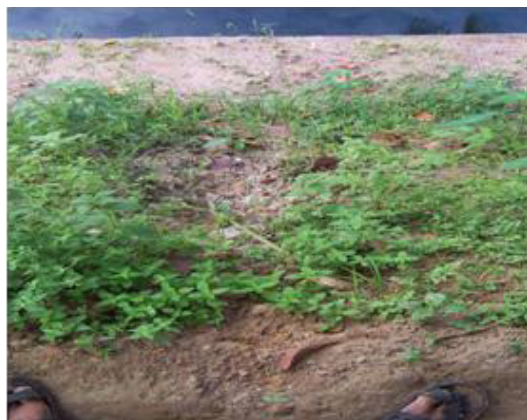
Fig. 8. CP-less density, non uniform vegetation with soil erosion, after 7 months.
